From: Stephen Best
To: Flock Safety Support
Cc: Gina Rush; Scott Casey; Trevor Hutton; brendon.norton@flocksafety.com; libby.landers@flocksafety.com; Daniel Rios; Eligio Lara; Daniel Cohen; Michael Balcorta; Stephen Best
Subject: RE: UPDATE RE: Disappointment with Flock.... also possible camera adjustment Cam "030 SB Broadway (South of Carmen-Lane 2 and 3)
Date: Friday, January 5, 2024 11:56:24 AM
Attachments: image001.png

<sbest@cityofsantamaria.org>
Subject: RE: UPDATE RE: Disappointment with Flock.... also possible camera adjustment Cam "030 SB Broadway (South of Carmen-Lane 2 and 3)

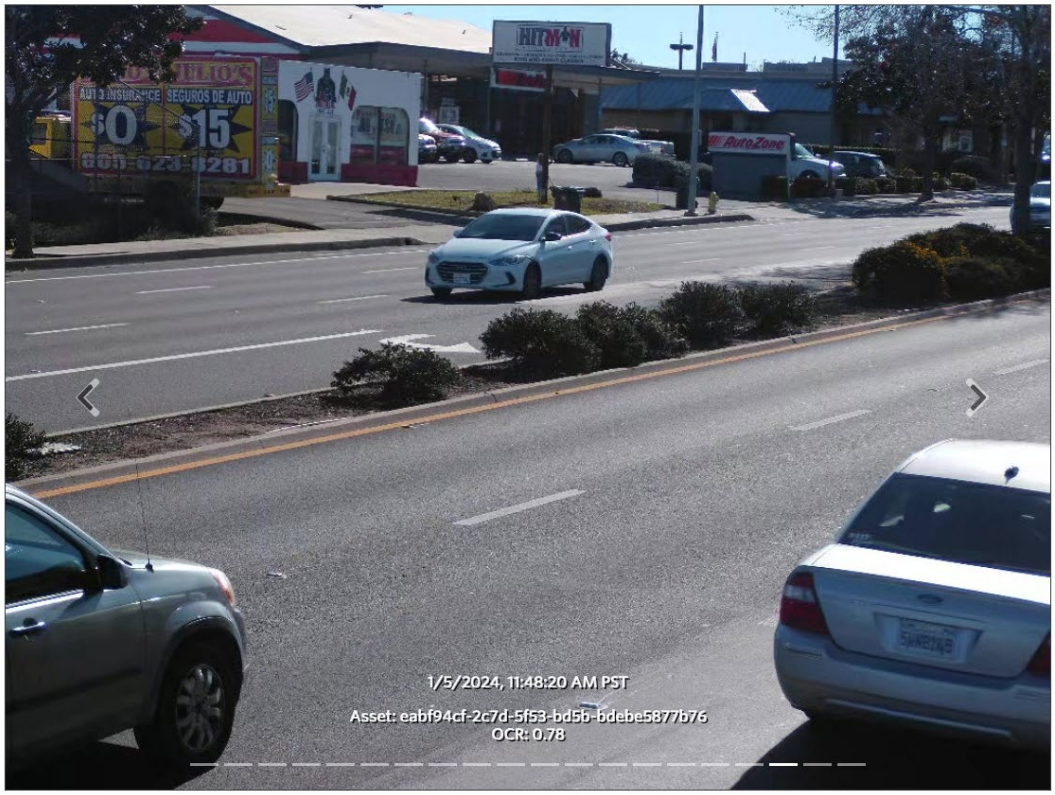
That is a bit better. Has a chance to catch some lane 3 cars.
Don't you think it is still filming too much of the N/B lane and buildings across the street?
If it was angled more to the right, I think it would have a better chance of getting multiple shots of lanes 1, 2 and 3.
If you think making that angle adjustment won't adversely affect lane 1, please schedule the work to be done.

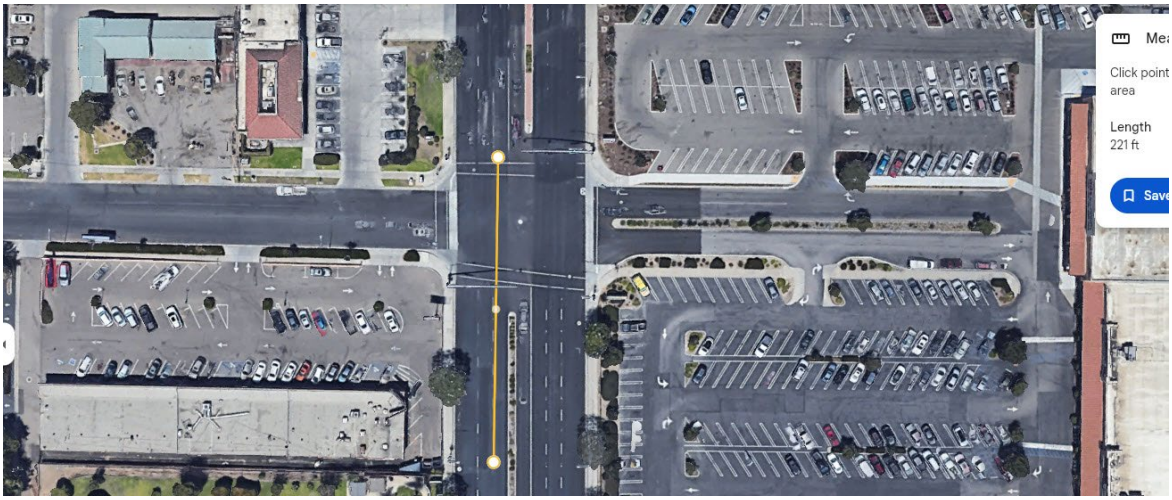
> Flock Safety Support,
> I'm writing to express disappointment with the performance of your cameras on a recent case.
> A semi tractor pulling a tanker trailer entered our city and stole 6,000 gallons of fuel and left without being recorded by any of our 166 Flock cameras.
> Video shows it traveling s/b on Broadway from the 1800 block on 12/24 at 06:54:01 Hrs.

Flock Camera “030-SB Broadway (south of Carmen-Lane 2 and 3) is less than 200 feet away and the truck definitely passes the camera as there is no place to turn prior to the camera.

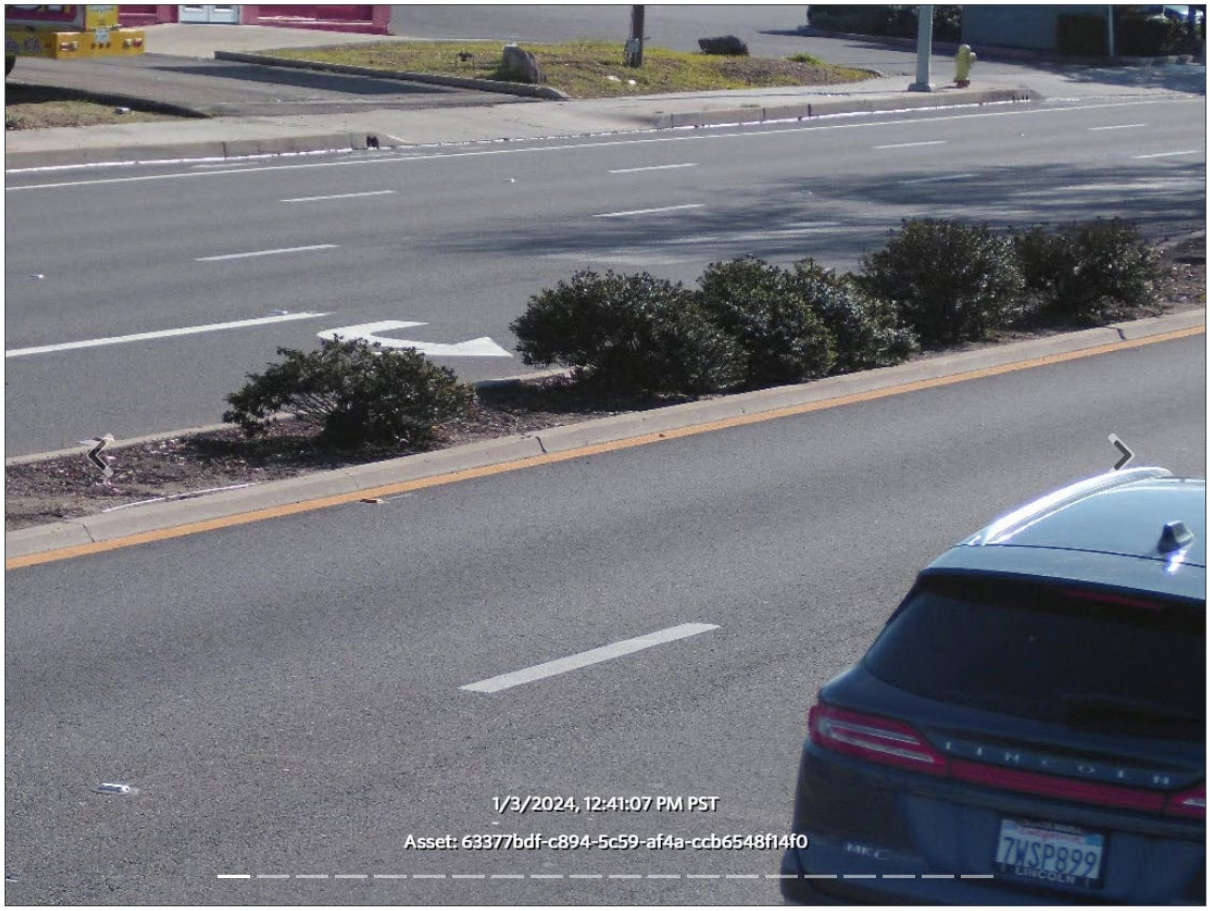
Hi Corporal Best,
Adam here. I'm very sorry to hear about this miss. It appears to be too tight of an angle to capture a vehicle as long as this fully, if at all in this case. Angling the camera further to the right could presumably allow the vehicles to be in frame longer, but of course that would also alter the way the results appear for other vehicles. Happy to give it a shot if you'd like, just let me know.

As far as Adjustments. Camera "030 SB Broadway (south of Carmen-Lane 2 and 3) clearly is pointing more at Lane 1 and 2. (which I think is ok, so I may re-name the camera)
Do you think moving the angle more to the right might get better coverage of Lane 1 and 2 and possibly a bit of lane 3 and not so much of the n/b lanes?

Also, can the timing be changed on the camera so it can get multiple images of each passing vehicle and maybe get the side and rear of semi trucks?
